Comments received for CHA Draft Report (*December 18, 2009*, CHA Project No. 20085.9000.1510) for the Assessment of Dam Safety of Coal Combustion Surface Impoundments Louisville Gas & Electric Company – Cane Run Power Station, Louisville, KY. Comments include;

Project: Cane Run Station - ATB/E-Pond Crest Borings

Remarks: **ATTERBERG LIMITS RESULTS** Test Method - ASTM D4318 Project: ATB / E-Pond Complex Project No: 3143-10-1216 Checked By: **MACTEC**

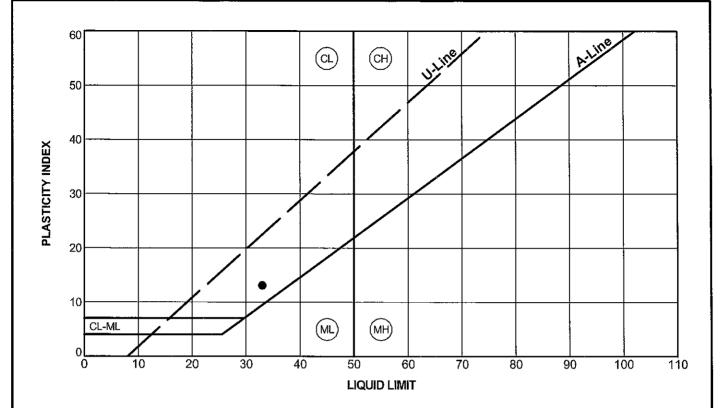
Symbol	Location	Depth, feet	LL	PL	Pi	Natural Moisture Content, %	LI	uscs	Soil Classification
•	B-1C	10.0-12.0	33	20	13	16.3	-0.3	CL	Grayish brown, lean CLAY

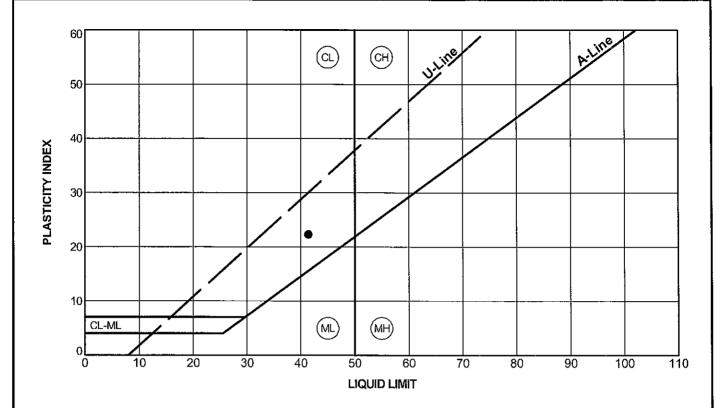
Symbol	Location	Depth, feet	J	빋	PI	Natural Moisture Content, %	LI	uscs	Soil Classification
•	B-1T	10.0-12.0	41	19	22	22.0	0.1	cL	Brown, lean CLAY

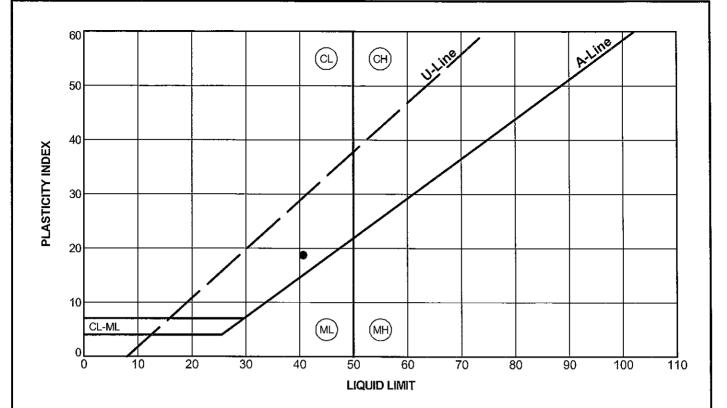
Symbol	Location	Depth, feet	LL	PL	Pl	Natural Moisture Content, %	П	USCS	Soil Classification
•	B-2C	5.0-7.0	41	22	19	14.5	-0.4	CL	Dark gray, lean CLAY

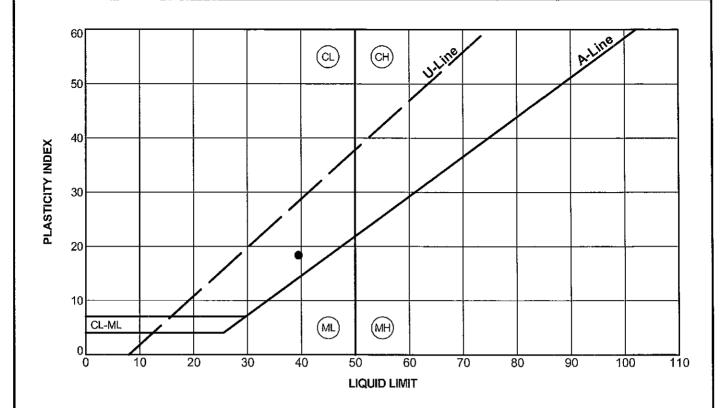
Symbol	Location	Depth, feet	LL	PL	Pl	Natural Moisture Content, %	LI	USCS	Soil Classification
•	B-2C	15.0-17.0	39	21	18	19.9	-0.1	CL	Brown, lean CLAY

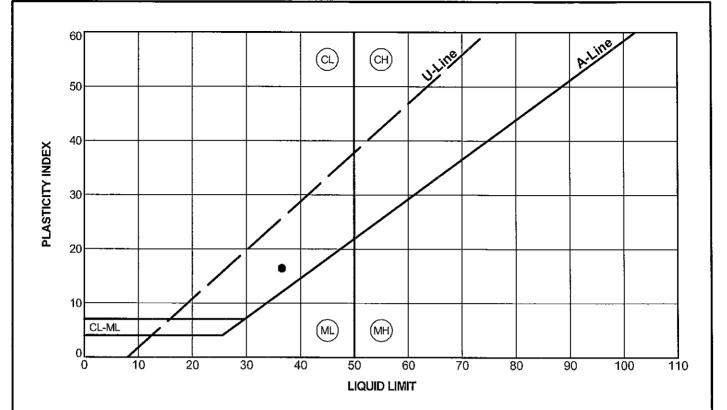
Symbol	Location	Depth, feet	LL	PL	Pl	Natural Moisture Content, %	ŁI	USCS	Soil Classification
•	B-3C	15.0-17.0	37	20	17	19.9	0.0	CL	Gray-brown, lean CLAY

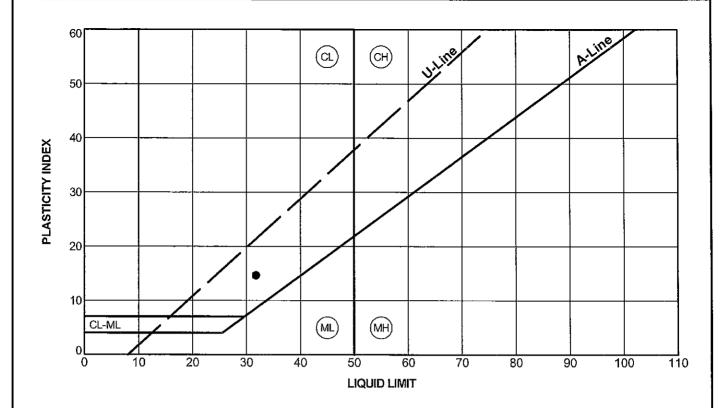
Symbol	Location	Depth, feet	LL	PL	PI	Natural Moisture Content, %	LI	USCS	Soil Classification
•	B-3T	5.0-7.0	32	17	15	21.0	0.3	CL	Brown, lean CLAY

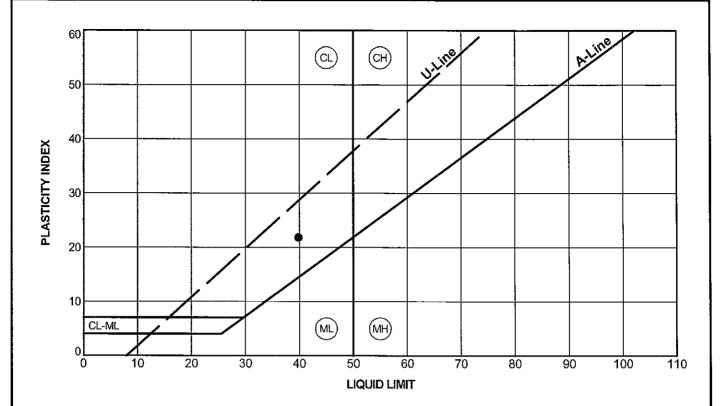
Symbol	Location	Depth, feet	LL	PL	PI	Natural Moisture Content, %	LI	uscs	Soil Classification
•	B-4C	10.0-12.0	40	18	22	19.3	0.1	CL	Brown, lean CLAY

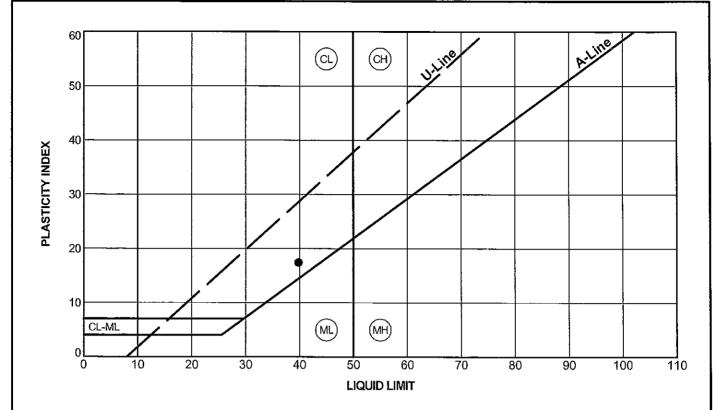
Symbol	Location	Depth, feet	J	PL	PI	Natural Moisture Content, %	LI	USCS	Soil Classification
•	B-5C	13.5-15.0	40	22	18	20.9	-0.1	CL	Brown, lean CLAY

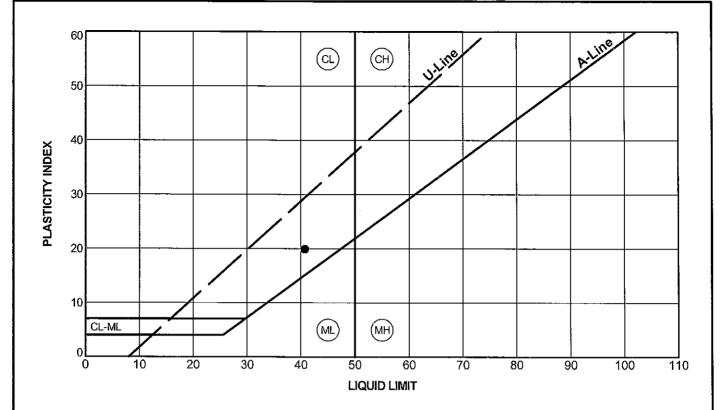
Symbol	Location	Depth, feet	LL	PL	Pl	Natural Moisture Content, %	LI	uscs	Soil Classification
•	B-5C	15.0-17.0	41	21	20	22.9	0.1	CL	Brown, lean CLAY

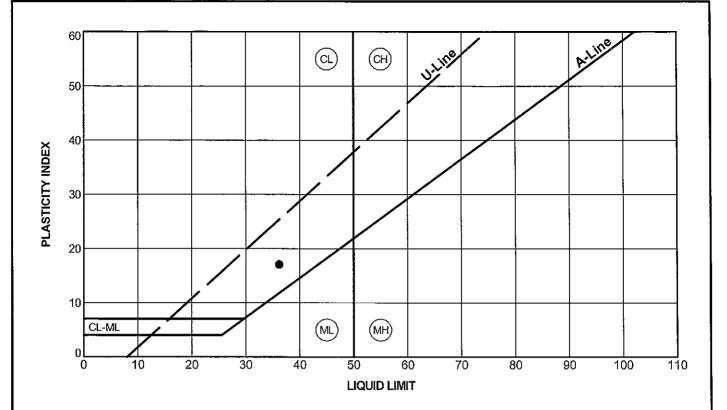
Symbol	Location	Depth, feet	LL	PL	PI	Natural Moisture Content, %	LI	uscs	Soil Classification
•	B-6C	1.5-3.5	36	19	17	15.9	-0.2	CL	Brown, lean CLAY

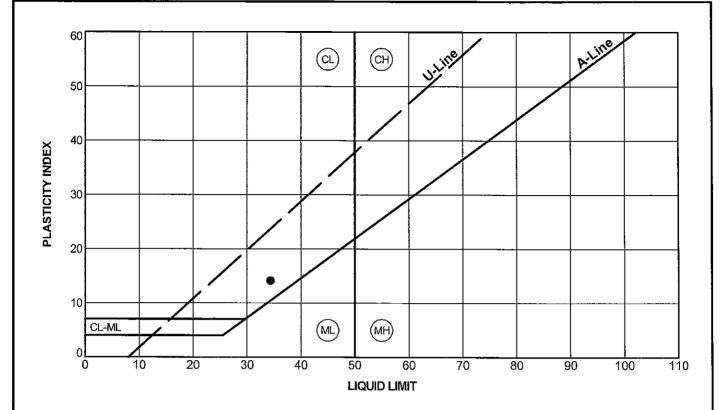
Symbol	Location	Depth, feet	1	PL	Pi	Natural Moisture Content, %	LI	uscs	Soil Classification
•	B-6C	8.5-10.0	34	20	14	17.9	-0.2	CL	Brown, lean CLAY

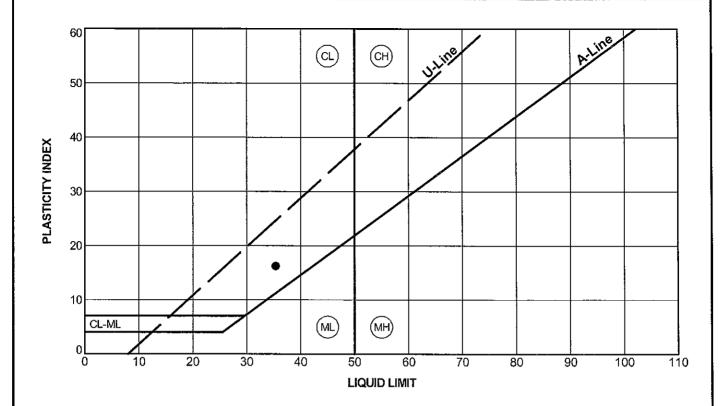
Symbol	Location	Depth, feet	L	PL	PI	Natural Moisture Content, %	LI	USCS	Soil Classification
•	B-7C	5.0-7.0	35	19	16	16.5	-0.2	CL	Brown, lean CLAY

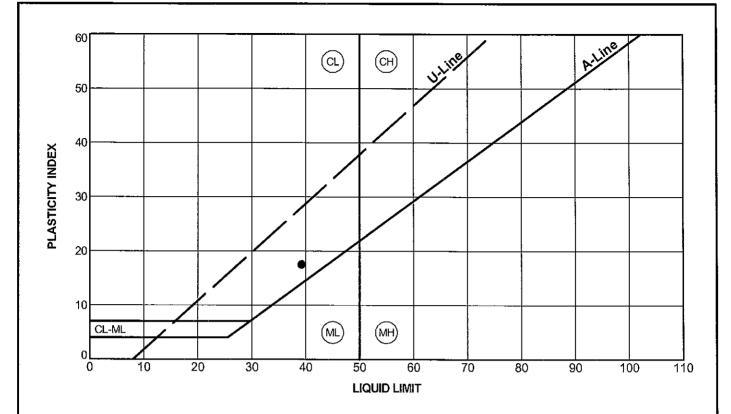
Symbol	Location	Depth, feet	LL	PL	PI	Natural Moisture Content, %	LI	uscs	Soil Classification
•	B-7C	15.0-17.0	39	22	17	22.1	0.0	CL	Gray, lean CLAY

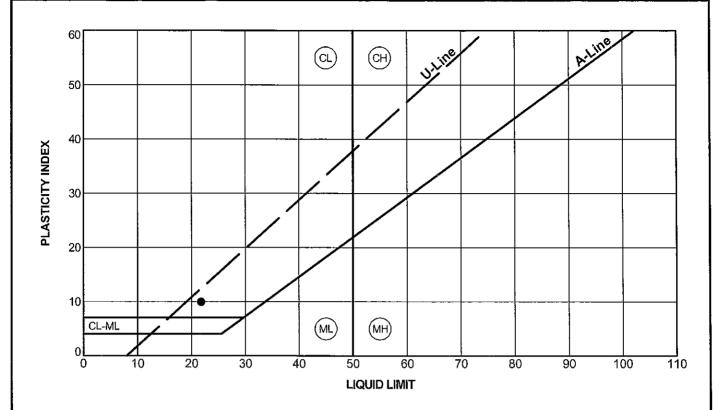
Symbol	Location	Depth, feet	LL	PL	PI	Natural Moisture Content, %	LI	USCS	Soil Classification
•	B-7S	50.0-52.0	22	12	10	16.1	0.4	CL	Dark brown, lean CLAY

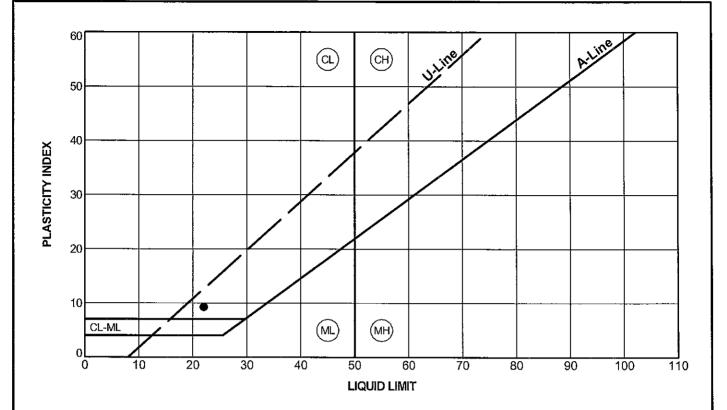
Symbol	Location	Depth, feet	님	PL	Pl	Natural Moisture Content, %	LI	USCS	Soil Classification
•	B-8C	10.0-12.0	22	13	9	13.1	0.0	CL	Dark brown, lean CLAY

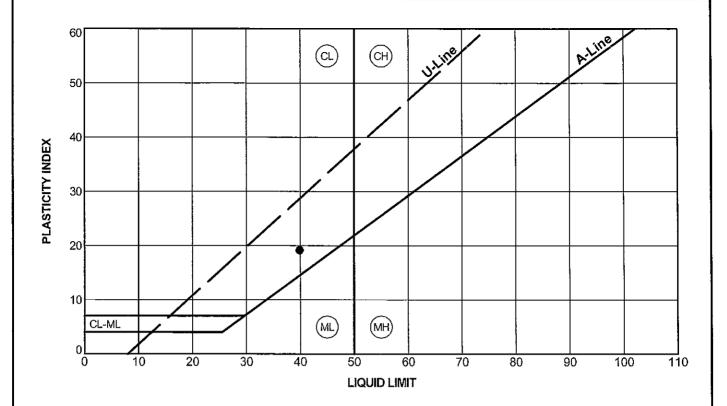
Symbol	Location	Depth, feet	긥	PL	PI	Natural Moisture Content, %	LI	USCS	Soil Classification
•	B-8C	20.0-22.0	40	21	19	20.6	0.0	CL	Brown, lean CLAY

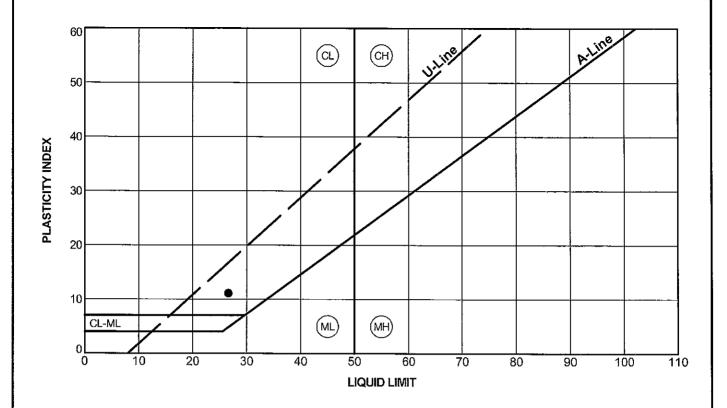
Symbol	Location	Depth, feet	LL	PL	PI	Natural Moisture Content, %		USCS	Soil Classification		
•	B-8S	15.0-17.0	27	15	12	16.5	0.1	CL	Medium brown, lean CLAY

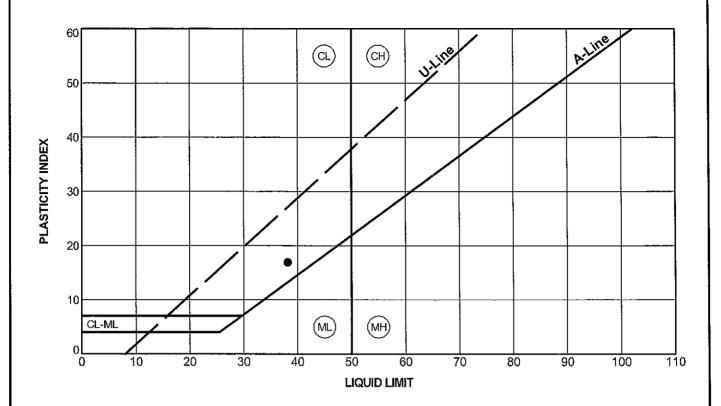
Symbol	Location	Depth, feet	LL	PL	PI	Natural Moisture Content, %	LI	USCS	Soil Classification
•	B-8T	5.0-7.0	38	21	17	26.5	0.3	CL	Brown, lean CLAY

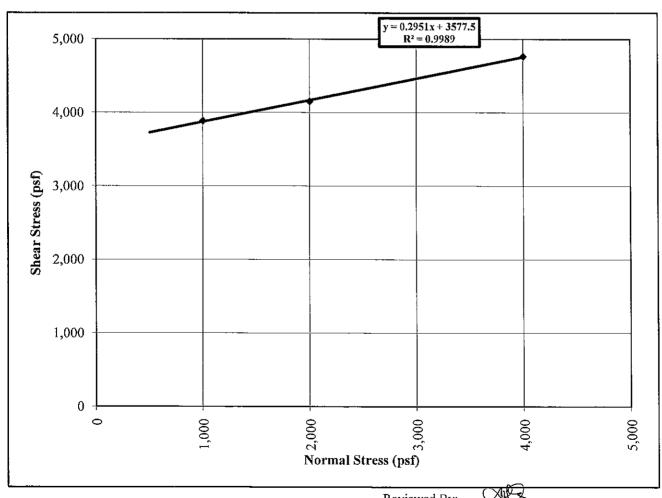
Cohesion: 3,578 psf Angle of Internal Friction: <u>16</u> °

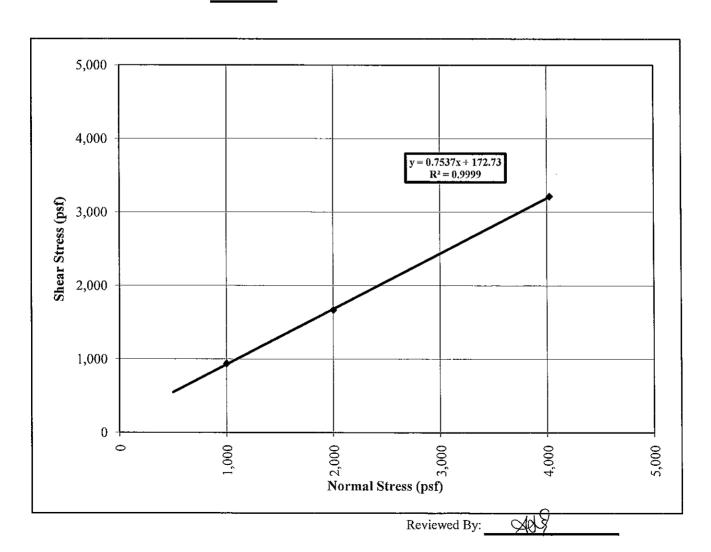
Normal Stress, psf	999	2001	4026
Shear Stress, psf	936	1,666	3,212
Initial Moisture Content, %	9.24%	8.72%	7.63%
Initial Dry Density, pcf	94.3	94.9	93.4
Final Moisture Content, %	23.2%	23.7%	23.9%

Cohesion: 173 psf Angle of Internal Friction: 37 °

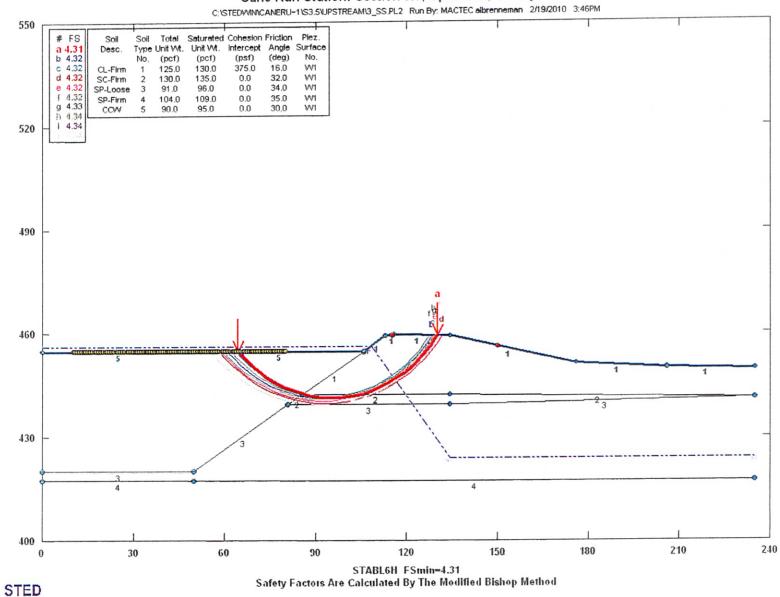
# Cane Run Station: Section 3.5, Upstream, Steady-State

#### Cane Run Station: Section 3.5, Upstream, Rapid Drawdown C:\STEDWIN\CANERU~1\S3.5\UPSTREAM\3\_RDD.PL2 Run By: MACTEC albrenneman 2/19/2010 3:50PM 550 Soil Total Saturated Cohesion Friction Piez. Type Unit Wt. Unit Wt. Intercept Angle Surface # FS a 4.42 b 4.42 Intercept Angle Surface Desc. (psf) (deg) No. (pcf) (pcf) c 4.43 130.0 375.0 16.0 VV1 125.0 CL-Firm SC-Firm 130.0 135.0 0.0 32.0 W W SP-Loose 3 91.0 96.0 0.0 34.0 35.0 W SP-Firm 4 104.0 109.0 0.0 g 4.43 5 0.0 30,0 VV1 CCW 90.0 h 4.43 520 i 4.43 490 460 430

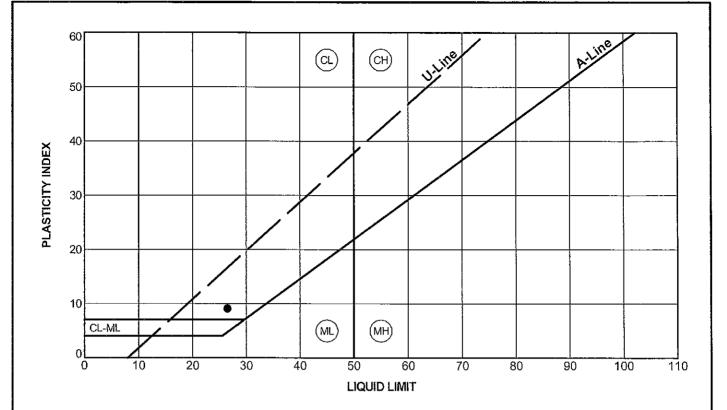
Symbol	Location	Depth, feet	LL	PL	PI	Natural Moisture Content, %	LI	USCS	Soil Classification
•	B-10C	15.0-17.0	26	17	9	18.2	0.1	CL	Brown, lean CLAY

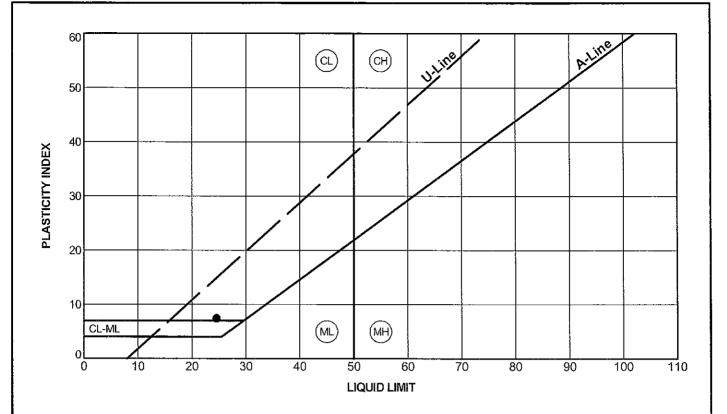
Symbol	Location	Depth, feet	LL	PL	Pl	Natural Moisture Content, %	LI	uscs	Soil Classification
•	B-10T	5.0-7.0	25	17	8	20.4	0.4	CL-ML	Brown, silty, lean CLAY

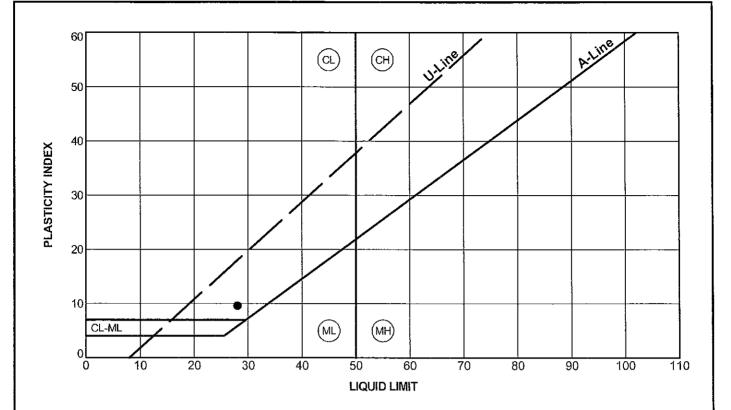
Symbol	Location	Depth, feet	LL	PL	PI	Natural Moisture Content, %	LI	USCS	Soil Classification
•	B-11C	10.0-12.0	28	18	10	17.6	-0.1	CL	Gray, lean CLAY

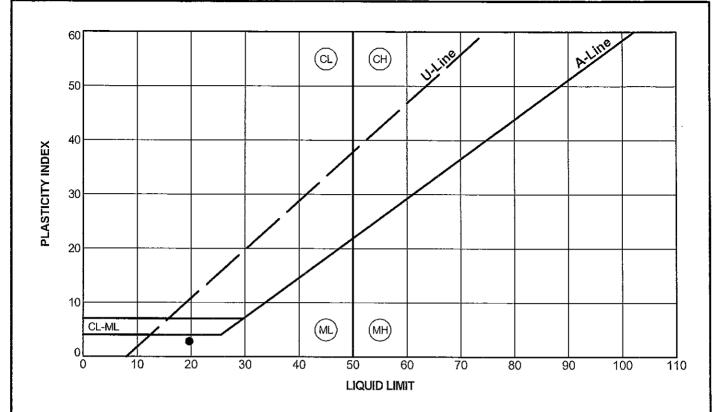
Symbol	Location	Depth, feet	LL	PL	Pl	Natural Moisture Content, %	LI	USCS	Soil Classification
•	B-11C	25.0-27.0	20	17	3	24.6	2.7	SM	Orange brown, silty SAND

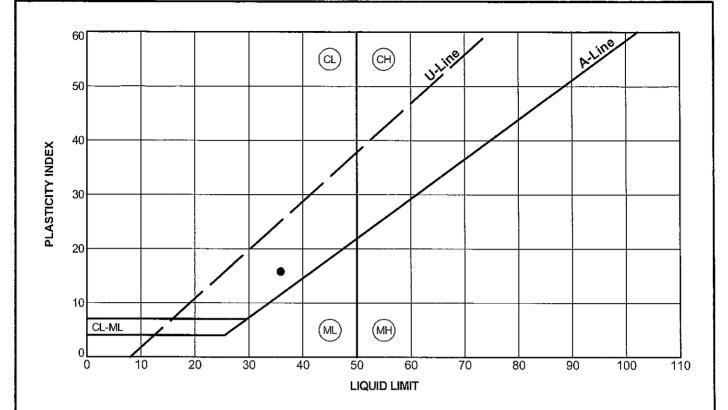
Symbol	Location	Depth, feet	L	PL	PI	Natural Moisture Content, %	Ll	uscs	Soil Classification
•	B-12C	5.0-7.0	36	20	16	21.6	0.1	CL	Orange brown, lean CLAY
